## Three-Dimensional Echocardiography in the Evaluation of the Dehiscence of Mitral Valve Annuloplasty Ring

Javier Urmeneta Ulloa, MD; Isabel Molina Borao, MD; Carmen Aured Guallar, MD; Pilar Lapuente González, MD; Eva Moreno Esteban, MD; Isabel Calvo Cebollero, MD

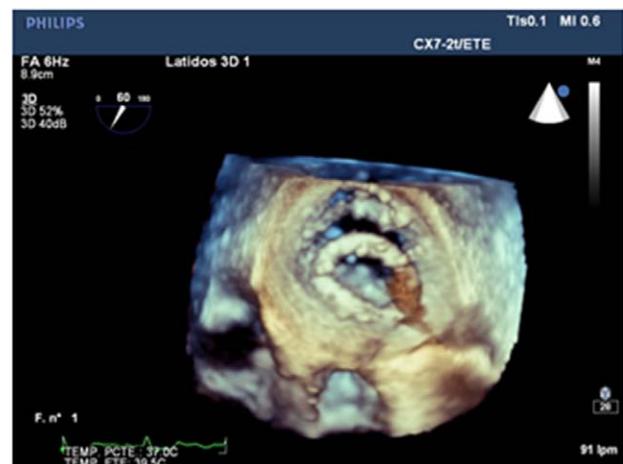
Figure 2. Dehiscence of the posterior mitral annulus.

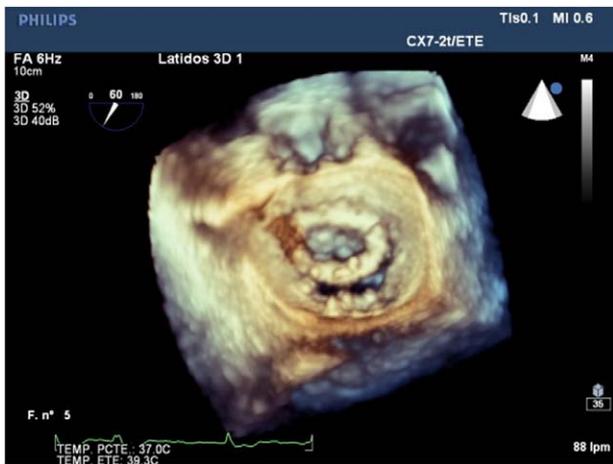
Figure 3. Dehiscence of mitral annulus.

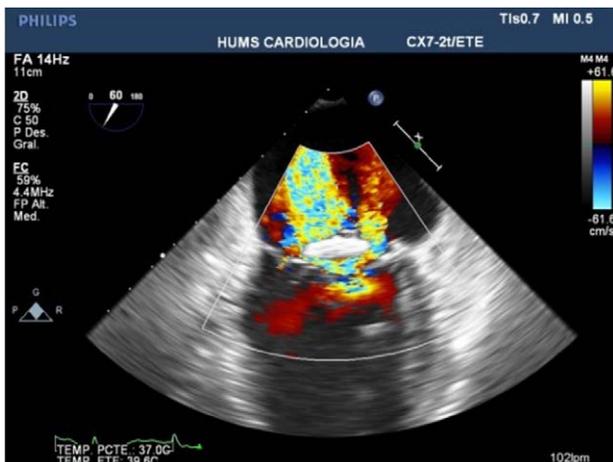
Figure 4. Severe myocardial insufficiency on the ring, creating 2 large mitral regurgitation jets.

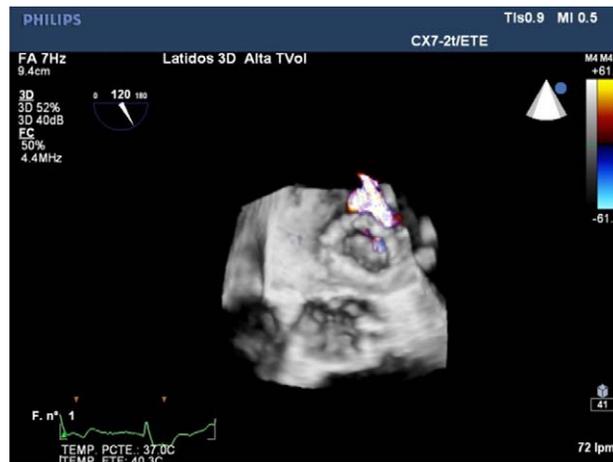
Figure 7. Three-dimensional transesophageal echocardiography: regurgitation jet in mitral dehiscence with color Doppler.

In our patient, the mitral valve dehiscence defect was in the posterior region (Figures 5– 8), confirming, as in the cases described in the literature, that there is a greater likelihood of mitral valve dehiscence defect in the posterior and lateral region, very rarely seen in the anterior location.<sup>2–4</sup> Several theories have been proposed to explain the increased likelihood of the occurrence in the posterior region of the mitral annulus, related primarily to limitations of the surgical field and structures surrounding the mitral valve apparatus.<sup>2</sup> First, the deeper location of the mitral valve annulus in its posterior part represents a more remote surgical field with a limited window that hinders the successful completion of the suture by the surgeon.<sup>2–4</sup> Second, the surgeon avoids placing sutures deep in the posterior part so as not to affect the circumflex artery anatomically close by, leading to the suture being placed in the surface of the region.<sup>2–4</sup> Finally, the presence of fibrosis and calcification of the mitral ring are more prevalent on the posterior part, which impedes proper suture placement on it.<sup>2–4</sup> Moreover, the anterior mitral annulus is constituted by fibrous tissue, which is a relatively firm surface for proper suture placement by the surgeon with greater comfort and safety; however, because it lacks flexibility, it could set the ring fixed, generating tension and dragging the posterior part, with a consequent increased risk of dehiscence on it.<sup>2</sup>

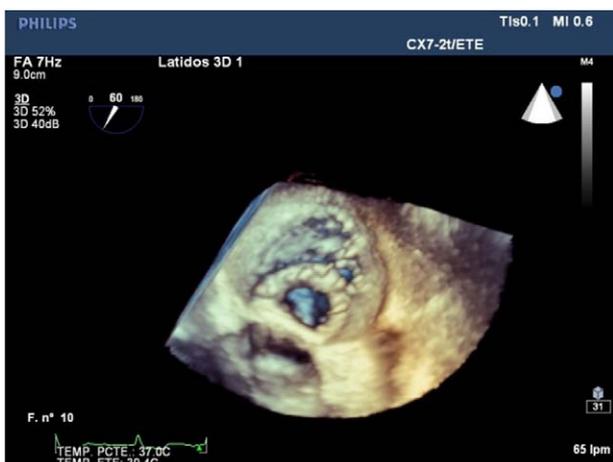
Figure 5. Three-dimensional transesophageal echocardiography: mitral ring dehiscence.

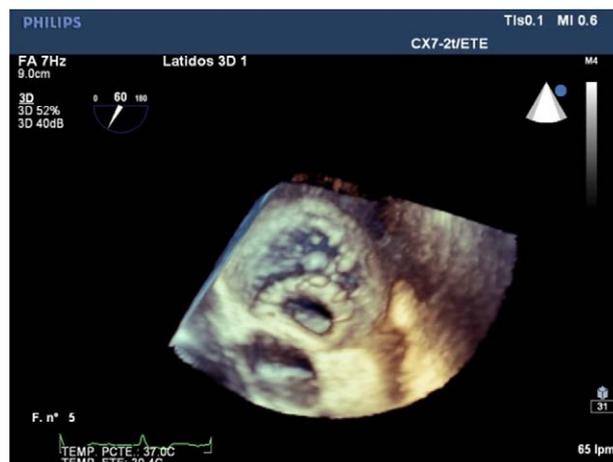
Figure 8. Three-dimensional transesophageal echocardiography: mitral ring dehiscence.
